Scientific Investigation of ABF[®] II Steel Pipe in Hybrid Fire Sprinkler Systems

Abstract

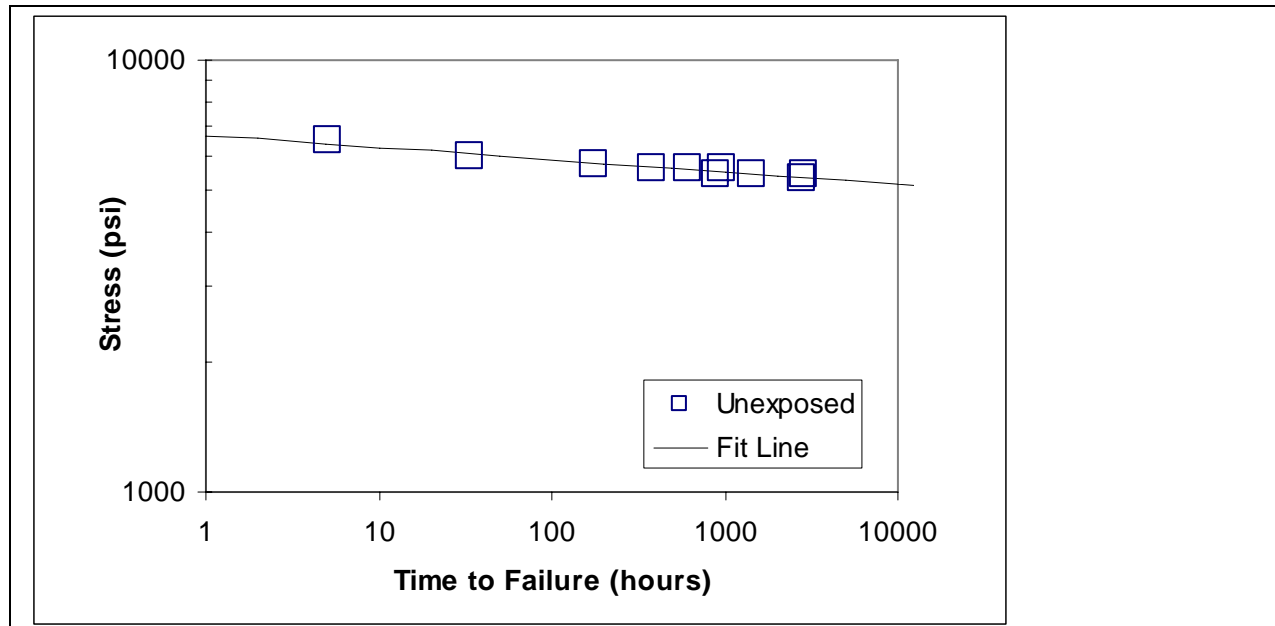
Control samples of CPVC pipe from the same lots used to construct the intermediate scale system were tested to determine baseline performance under unexposed conditions. Some specimens were tested in air and some were tested while immersed in deionized water. The results are shown in Figure 3 below. The data are well represented by a straight line on a log-log plot. There was no significant difference between specimens tested in air and specimens tested in deionized water. These results are consistent with the scientific literature concerning creep rupture testing of engineering plastics and with the performance requirements for CPVC piping used in fire sprinkler systems. The results shown in Figure 3 for the unexposed control samples provide the baseline for evaluation of potential exposure to ABF II in the intermediate scale experiment.

Figure 3. Creep rupture testing of unexposed control samples.

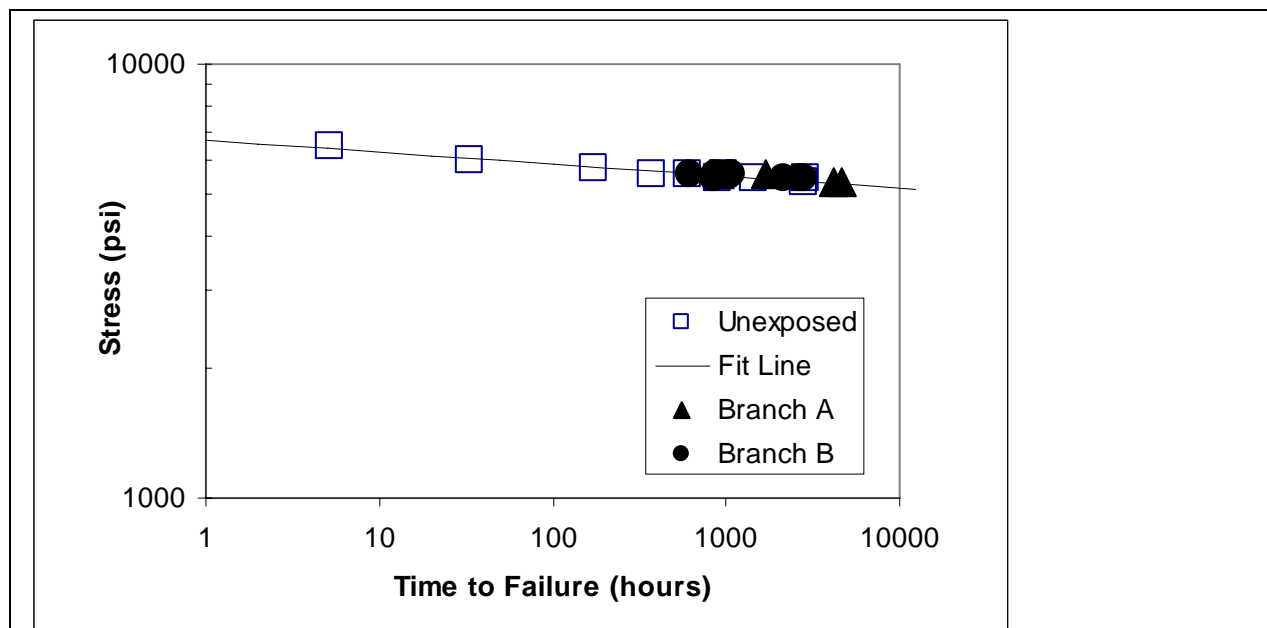
Samples of CPVC pipe from the intermediate scale branch lines 1A and 1B both with and without cutting oil were tested by tensile creep rupture in air. The end-of-line branch line “1” was selected for testing because it represented the worst case scenario from the intermediate scale configuration, the branch line where the highest concentrations of chemicals were found after exposure. Branch lines “A” represent exposure during initial fill of the system while branch lines “B” represent exposure during the initial fill, the subsequent fill, and contact with stagnant water for long periods of time. The closed symbols in Figure 4 below show the results in comparison with the control baseline. The specimens that had been exposed to ABF II performed just as long as the unexposed specimens when subjected to the same levels of mechanical stress. Under these test conditions the performance of the exposed CPVC pipe was indistinguishable from that of new, never installed CPVC control samples.

Figure 4. Creep rupture testing in air of branch line samples from the intermediate scale experiment.

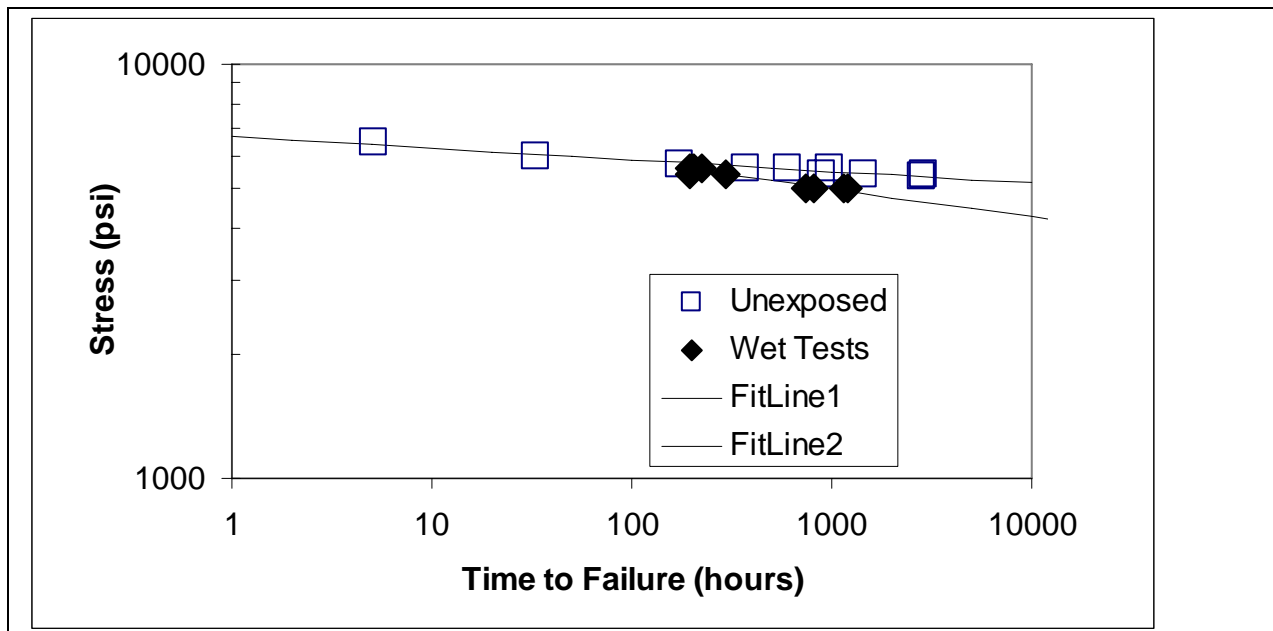
The closed symbols in Figure 5 below show the available results for the “wet” samples in comparison with the control baseline. Testing of additional specimens at lower tensile stresses is ongoing. The data from the “wet” samples, at this point comprising ten individual data points, are well represented by a straight line on the log-log plot. The CPVC branch line samples tested in water from the same branch line show a slight reduction in long-term performance, indicating a mild detrimental effect of exposure. This reduction in performance is significantly less than the reduction observed when other commonly used ancillary products are tested in contact with CPVC. The performance of the “wet” samples as represented by the extrapolated fit line is also only slightly lower than that required of new, never installed CPVC sprinkler pipe. The design of these systems includes a “service design factor” (safety factor) “which takes into

consideration all the variables and degree of safety involved in a thermoplastic pressure piping installation.”^{8,9} The long-term extrapolated (to 100,000 hours) “wet” sample results represent a change of only 10% in the prescribed service design factor.

Figure 5. Creep rupture testing in branch line water of branch line samples from the intermediate scale experiment.
