ABF II COATING

Advanced MIC Prevention Breakthrough

**allied**
TUBE & CONDUIT

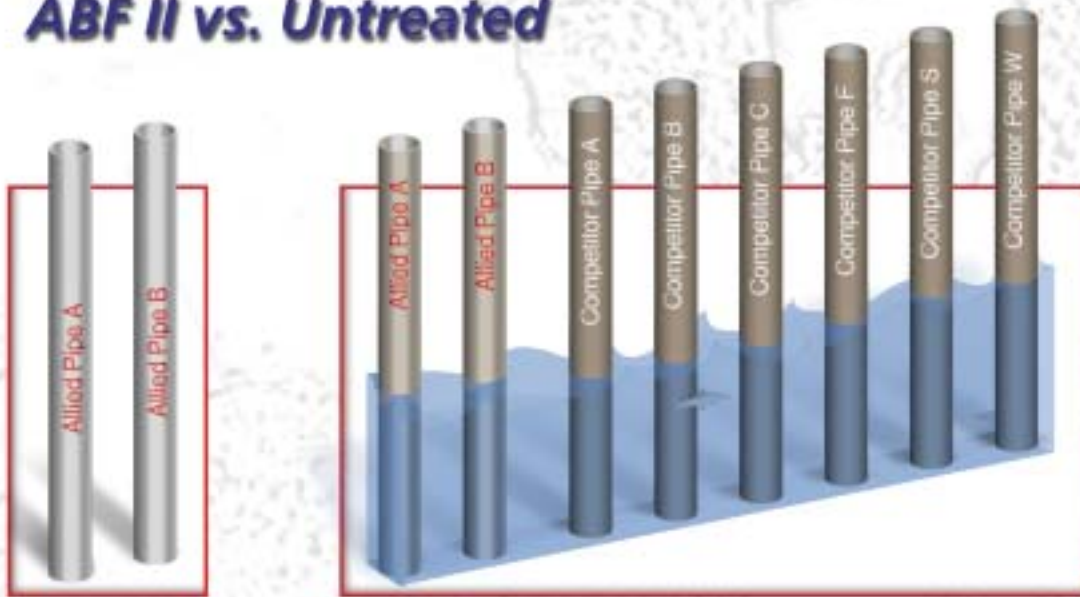
ABF II vs. Untreated

ZERO BACTERIA

> 1,000 BACTERIA

per square inch pipe surface

Allied and competitive sprinkler pipe samples were exposed to water up to fifteen days. In that time, only the Allied samples coated with ABF II protection did not show any sign of MIC. All other samples without ABF II (including the Allied control samples) were colonized by more than 1,000 of each type MIC bacteria.

Bacterial tests performed by BioIndustrial Technologies, Inc., proved that ABF II effectively prevents the initial onset of MIC bacteria formation.

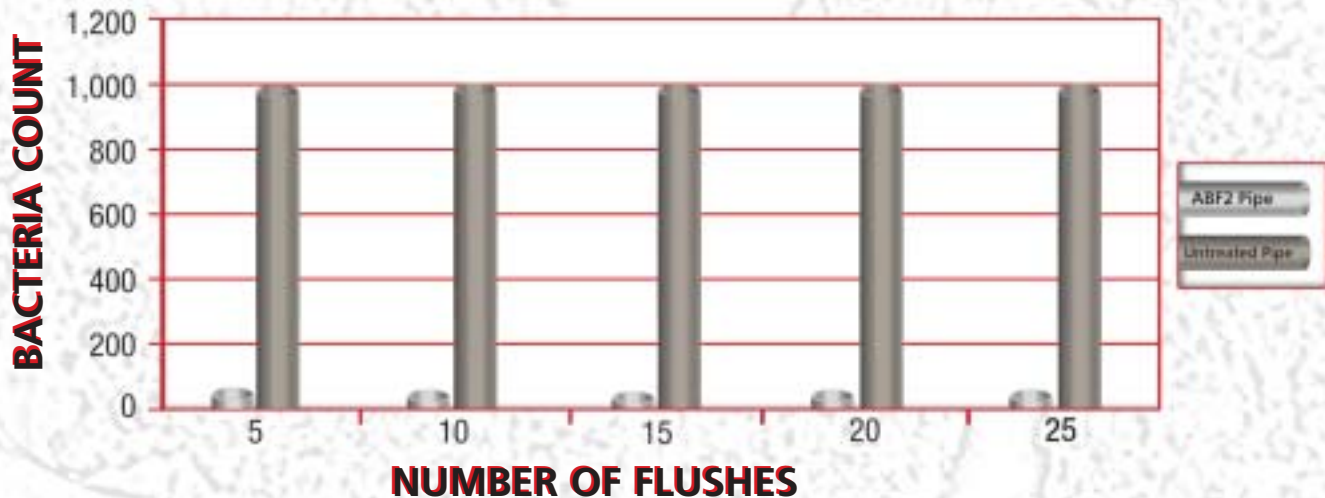
In laboratory testing ABF II maintained a minimal bacteria count even after 25 flushes of the pipe.
